# New York State Department of Transportation

## Yellow Flag NB2222W010

**BIN: 1065318**  
**Feature Carried:** 278I278IX2M23027  
**Feature Crossed:** 6TH AVENUE  
**Orientation:** 8 - NORTHWEST  
**Region:** 11 - NEW YORK CITY  
**County:** KINGS  
**Political Unit:** City of NEW YORK  
**Approximate Year Built:** 1962  
**Posted Load Matches Inventory :** Yes  
**Bridge Load Posting (Tons) :** Not Posted for Load  
**Primary Owner:** New York State Department of Transportation  
**Primary Maintenance Responsibility:** 12 - State - Subcontracted to another Party  
**Typical or Main Span Type:** 3 - Steel, 02 - Stringer/Multi-Beam or Girder  
This Bridge is not a Ramp  
**Number of Spans:** 322

Location: Span 253, Girder G4 at Pier 253

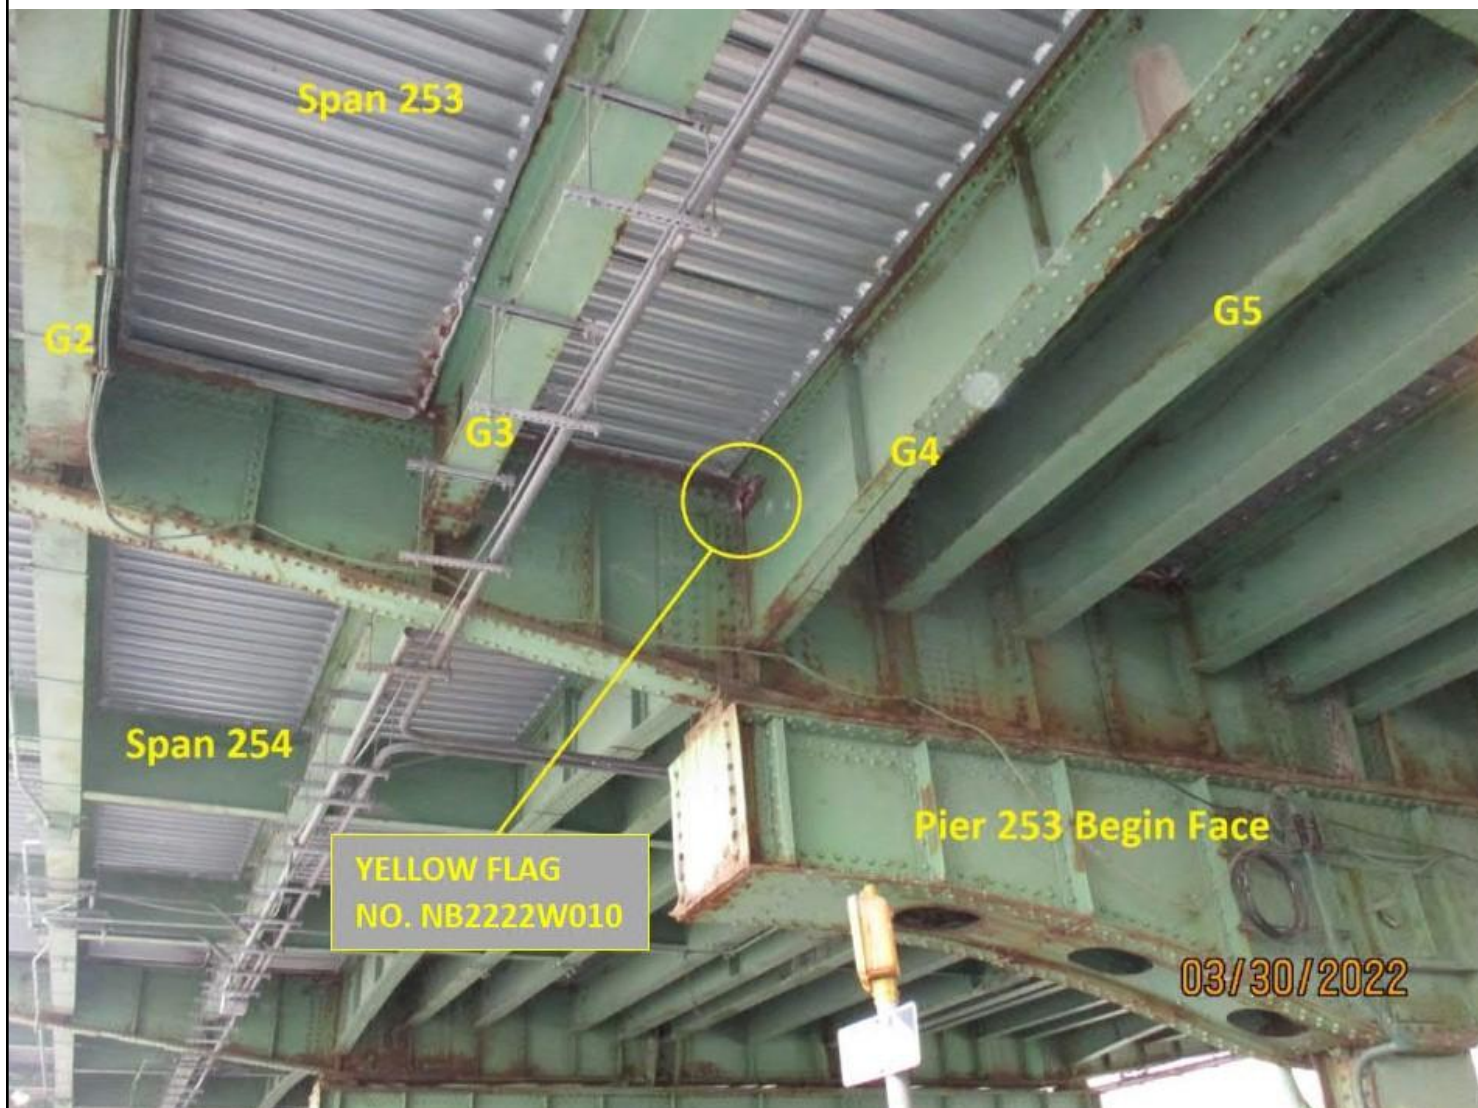
Photo Number: 1

**Attachment Description:** Span 253, Girder G4 at Pier 253 - General View of flagged location. Looking End Right.

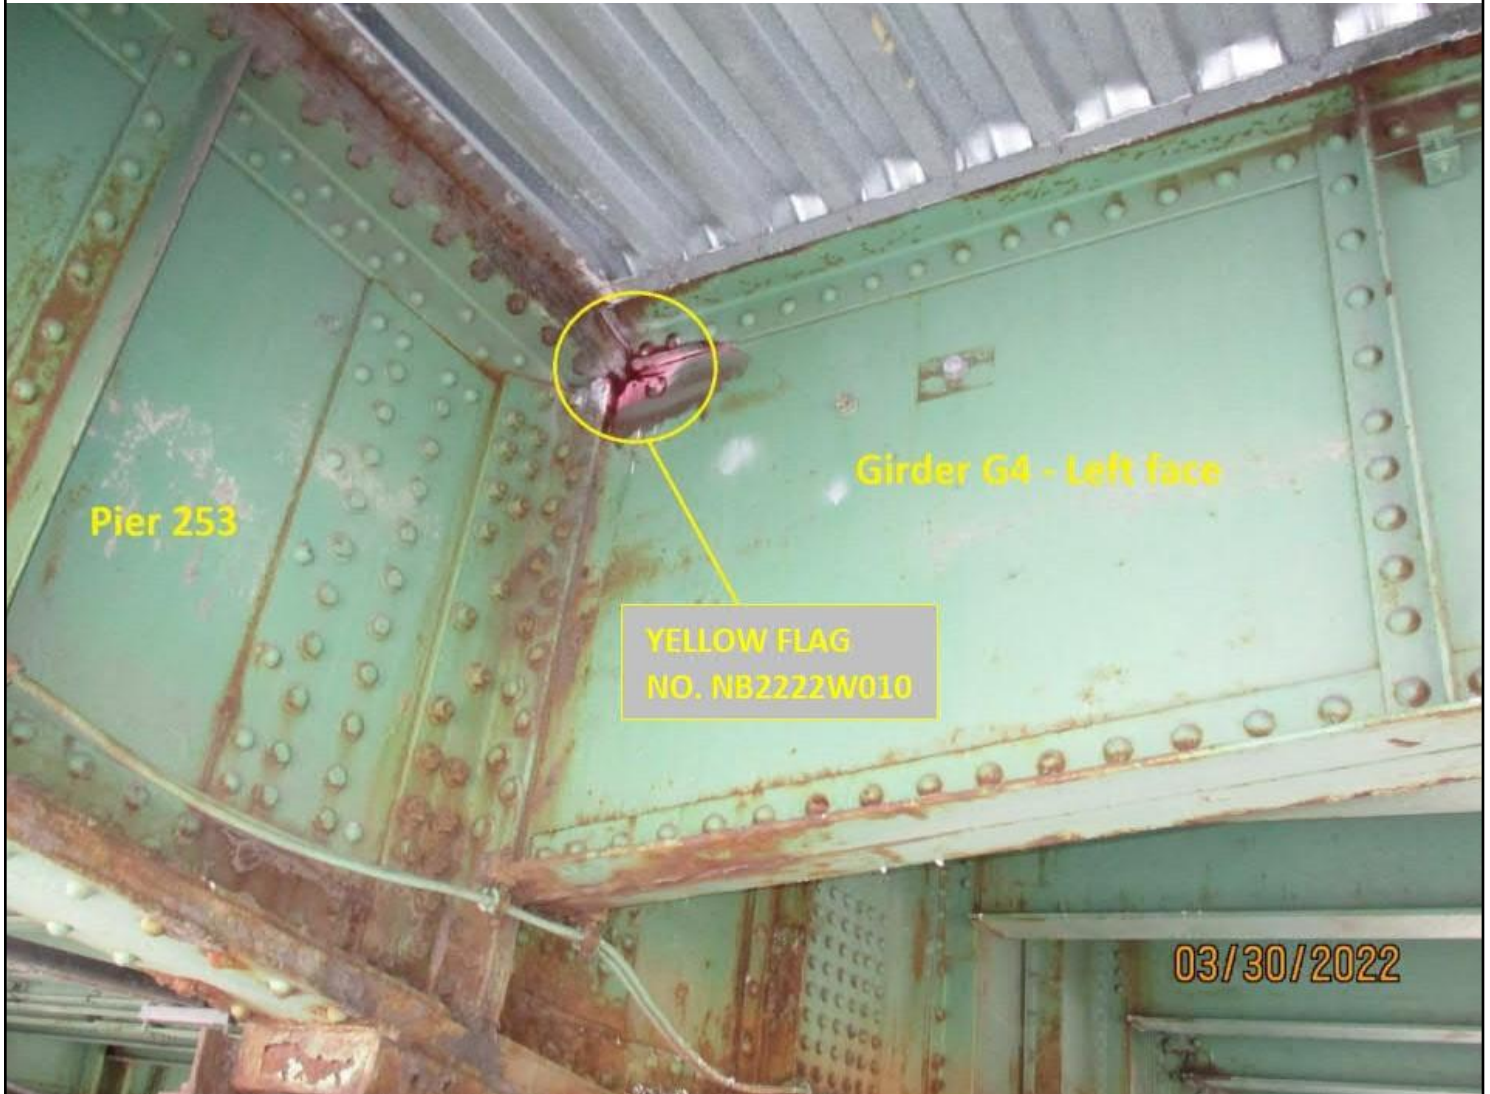
Photo Number: 2

**Attachment Description:** Span 253, Girder G4 left face at Pier 253 - Overall view of flagged location. Looking End Right.

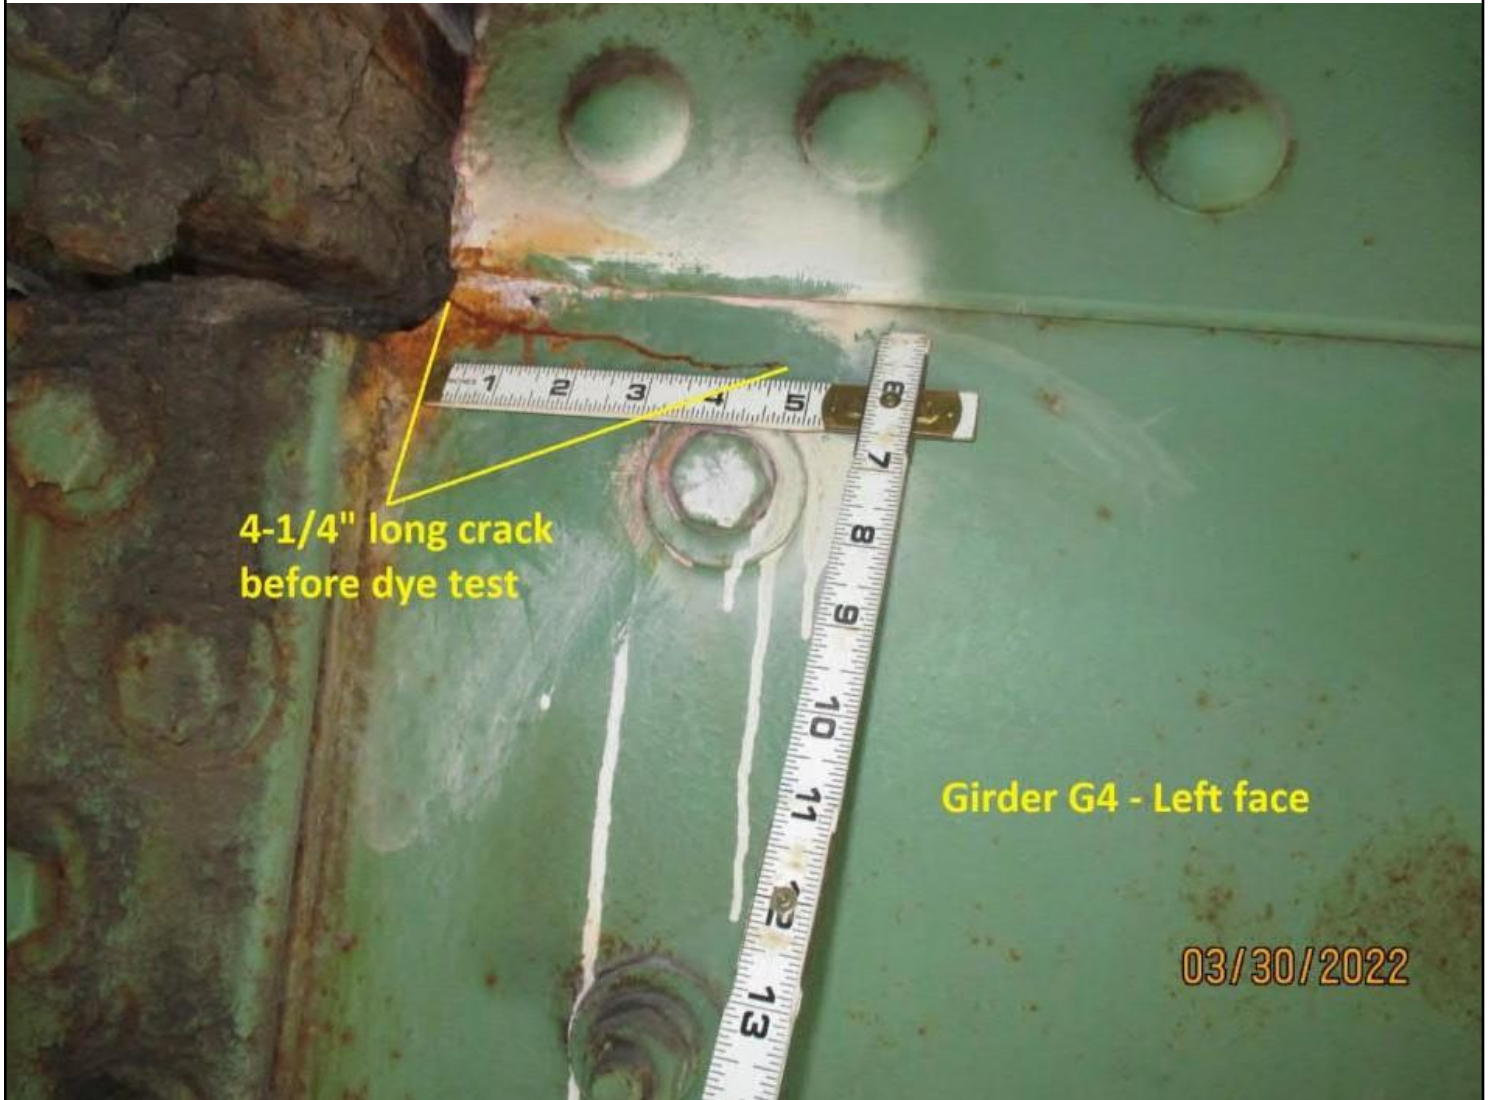
Photo Number: 3

Description: The web of Girder G4 exhibits a 4.5" long diagonal (almost horizontal) crack at the top cope (no change from the previous inspection). The affected member, Girder G4, is a load path redundant built-up steel girder consisting of varying web depth x 3/8" thick and two equal leg angles (L 5" x 5" x 1/2") for the top and bottom flanges. The spacing between Girder G4 and G5 is 3'-9.75" on center and 6'-11" on center from G3.

**Attachment Description:** Span 253, Girder G4 left face at Pier 253 – Close up view of diagonal crack measured at 4-1/4 long at the top cope of the web - before dye test. Looking Right.

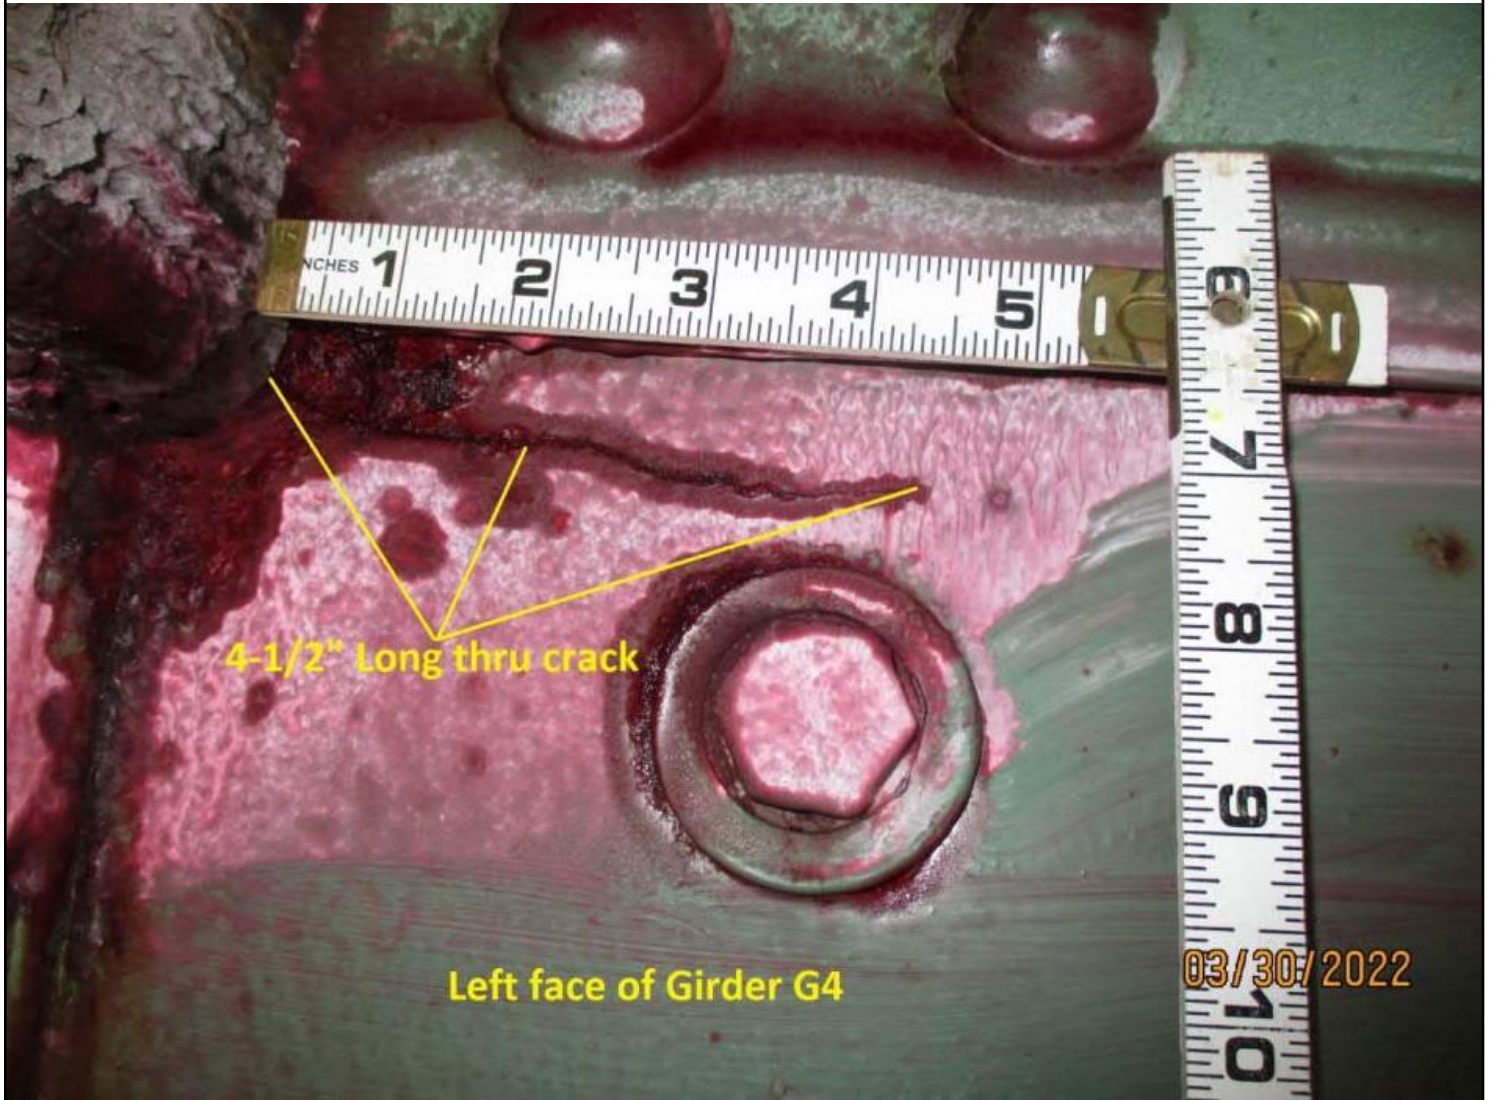
Photo Number: 4

**Attachment Description:** Span 253, Girder G4 right face at Pier 253 – Close-up view of diagonal crack measured at 4-1/2" long at the top cope of the web - after dye test. Looking Right.

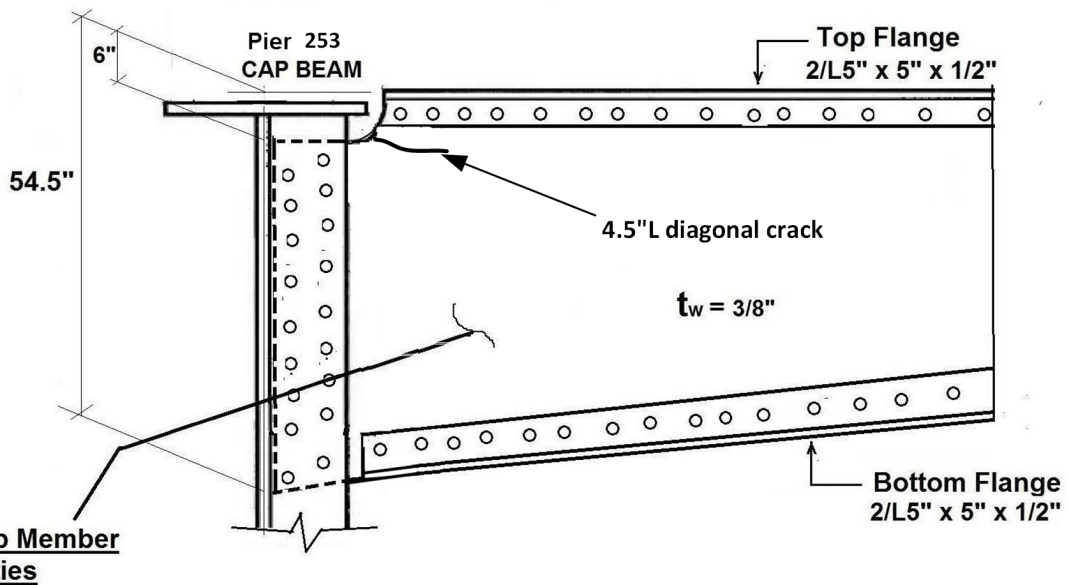
Photo Number: 5

Varying depth web: 54.5" b-to-b Ls @ Piers 252 and 253 and 33" @ midspan

Web thickness = 3/8"

Bottom and Top Flanges are two equal leg angles L 5" x 5" x 1/2"

**Span 253, Girder G4 at Pier 253****(Looking Right)****N.T.S.****Attachment Description: SN 253 G4 at Pier 253 Sketch**

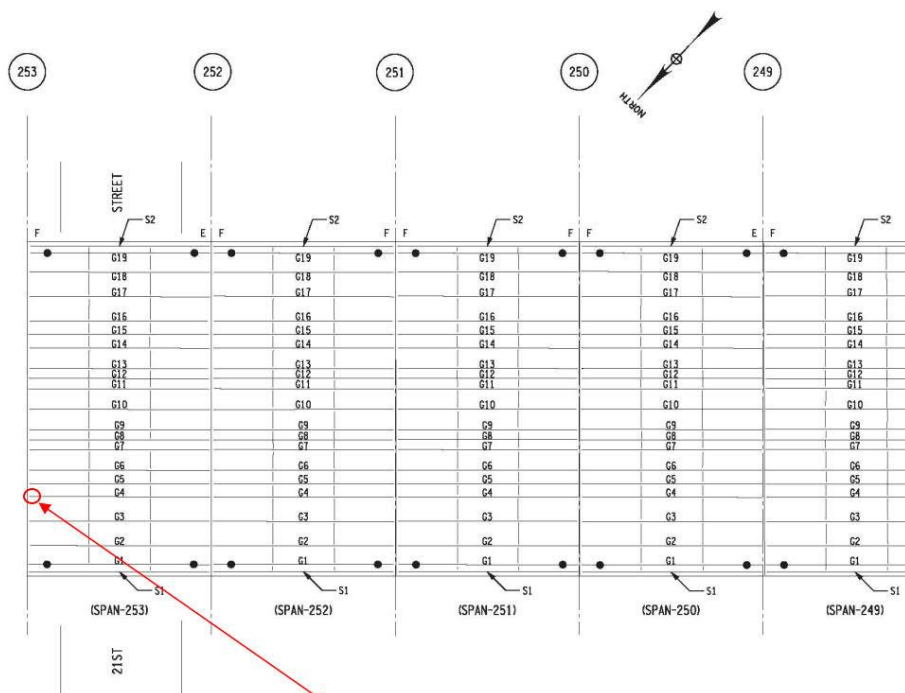
Photo Number: 6

**YELLOW FLAG  
LOCATION**  
**No. NB2222W010**

**Attachment Description: SN 253 G4 at Pier 253 Framing Plan**
